DRAFT SUMMARY REPORT AND CONCEPTUAL RI/FS WORK PLAN OUTLINE

**ROCKAWAY BOROUGH WELL FIELD SITE
OPERABLE UNIT #3
FOR PROPERTY OF
KLOCKNER & KLOCKNER
ROCKAWAY BOROUGH, NEW JERSEY**

**THE WHITMAN COMPANIES, INC.
EAST BRUNSWICK, NEW JERSEY**

DECEMBER 1995

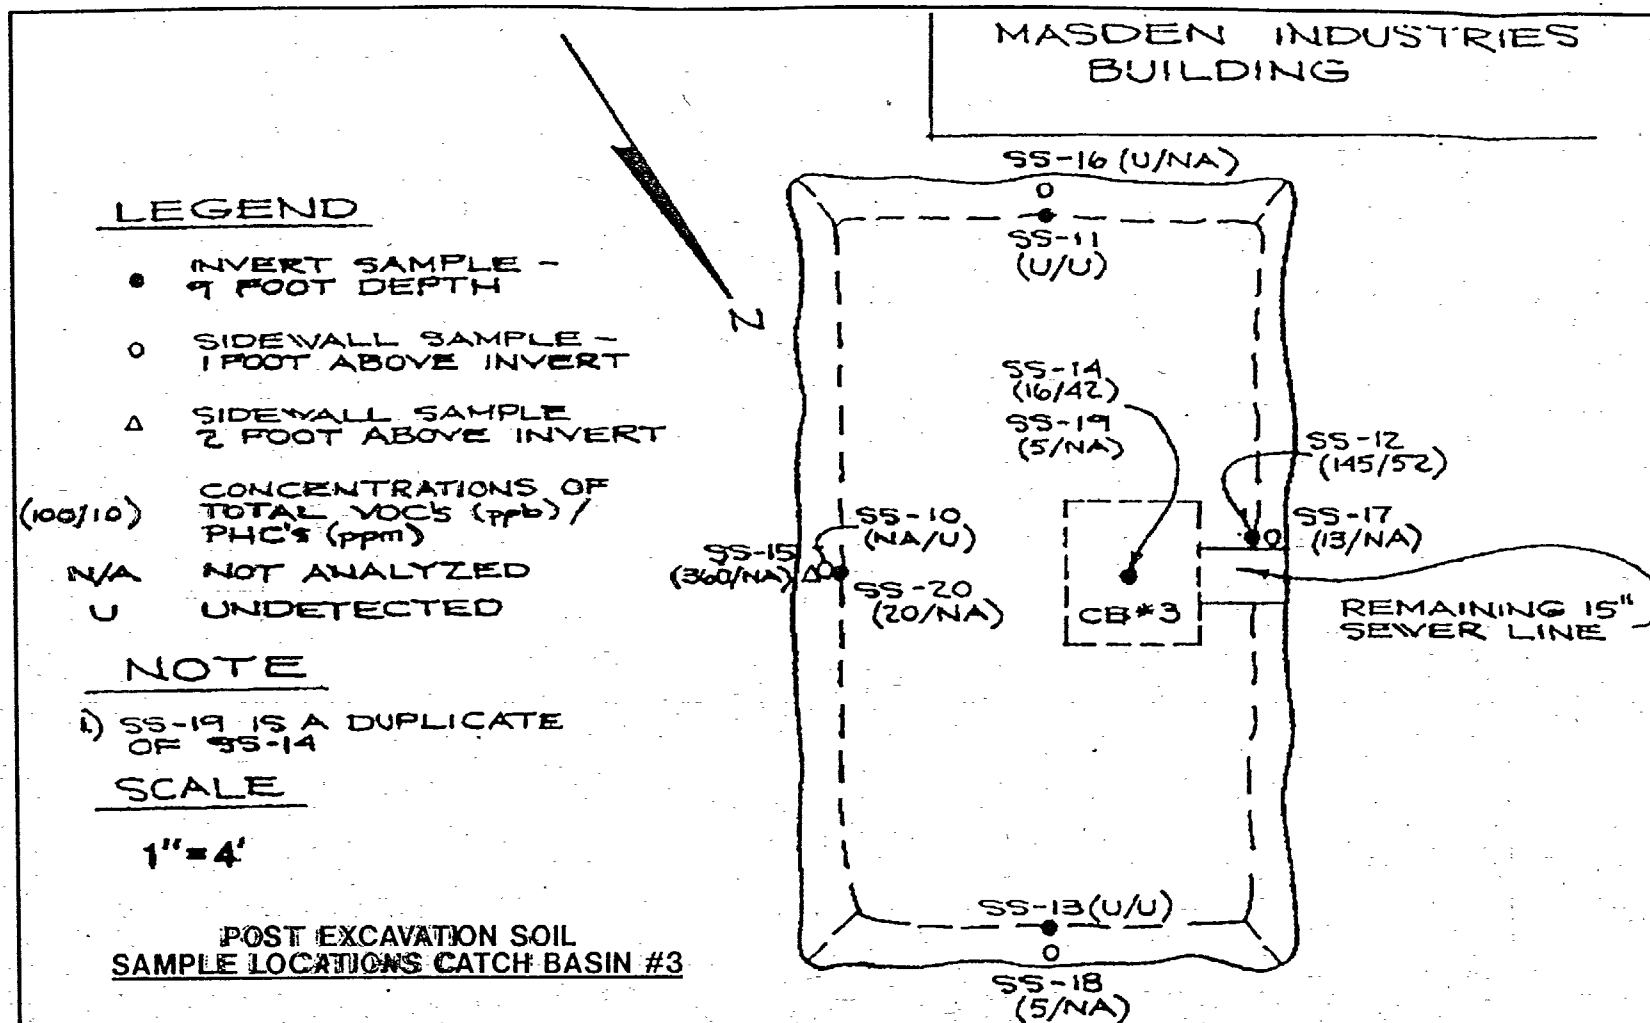
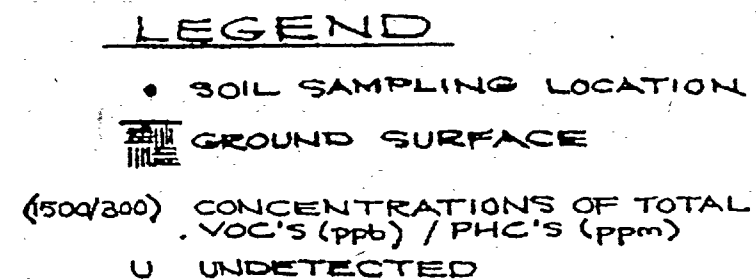
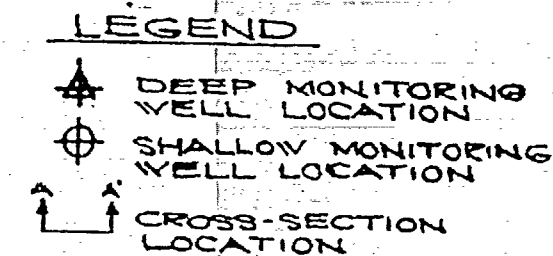
KLOCKNER & KLOCKNER PROPERTY ROCKAWAY BOROUGH MORRIS COUNTY, NJ		
	CATCH BASIN / STORM SEWER SAMPLE & EXCAVATION LOCATIONS		
ORIG. BY: MM	DWG. BY: A. Villar	CHK. BY: MM	
DWG. #:	DATE: NOV. 1995	FIGURE: 3.5

Sediment samples were collected from the catch basin closest to the alleyway (catch basin #3) on April 18, 1986 for PHC, PCB, VO+15 and EPTOX Metals (GTI, 1986). PHCs were detected at a level of 3,200 ppm. The VOCs detected were TCE at 478 ppm, PCE at 95 ppm and trans-1,2-Dichloroethene (T-1,2-DCE) at 9.4 ppm. PCBs and EPTOX Metals were not detected at levels of concern. An integrity test was conducted in 1987 by plugging the sewer line and charging water to the system. The test indicated that the system leaked. The analytical results are presented in Table 3.7. The sample locations are indicated on Figure 3.5.

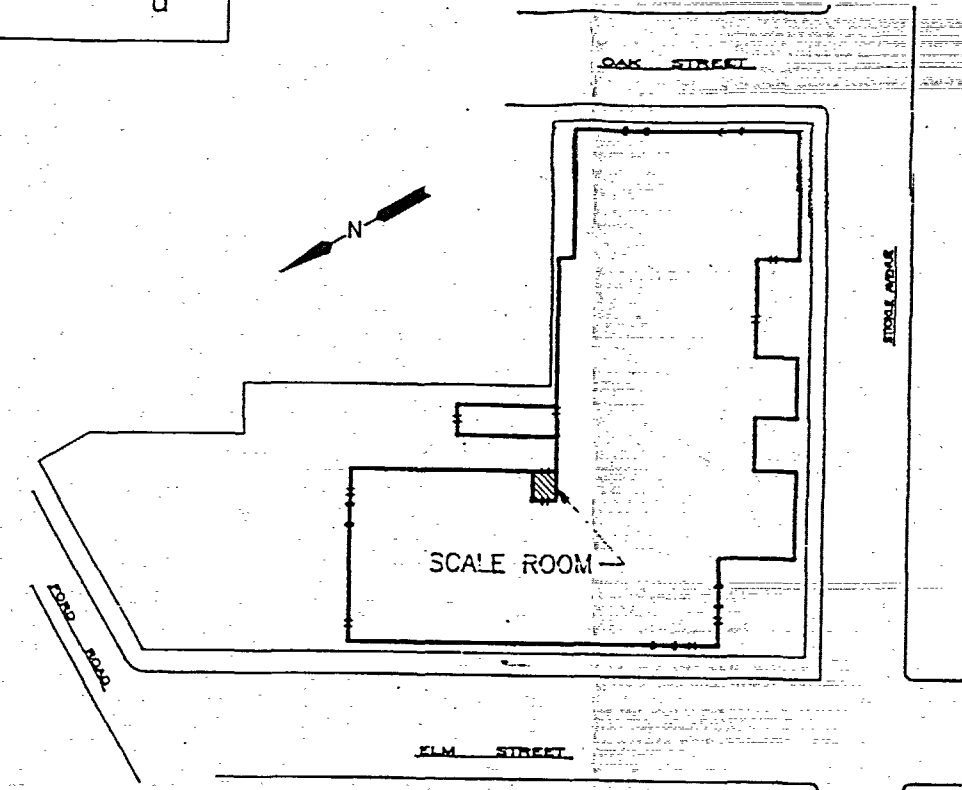
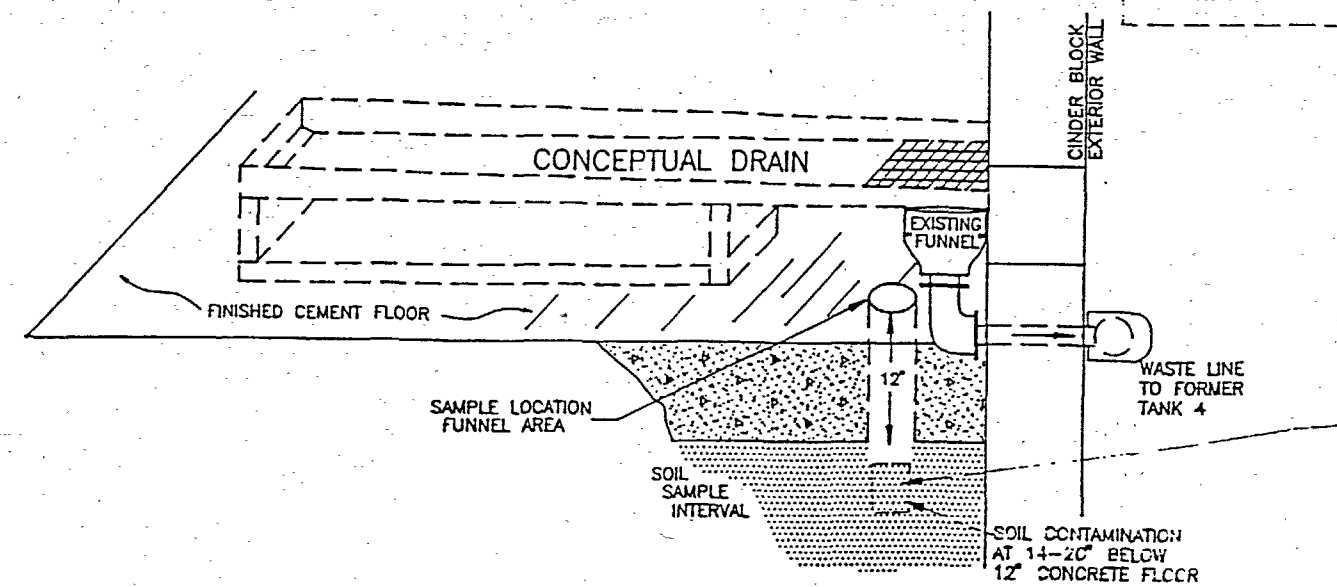
300152		
THE WHITMAN Companies, INC.			KLOCKNER & KLOCKNER PROPERTY ROCKAWAY BOROUGH MORRIS COUNTY, NJ		
ORIG. BY: MM			SAMPLE LOCATIONS SCALE ROOM		
DWG. #:			DATE: NOV. 1995		
DWG. BY: A. Villar			CHK. BY: MM		
FIGURE: 3.9

FUNNEL PIPE SAMPLE	
TCE	u
PCE	u

SCALE PIT BOTTOM SLUDGE (COMPOSITE SAMPLE)	
TCE	u
PCE	u

ICM LAB RESULTS	
FUNNEL AREA 14" - 20"	
TCE	16,000 ppb
PCE	12 ppb
T-1,2-DCE	1,100 ppb

CROSS SECTION VIEW
SCALE: NTS
